INTRODUCTION TO THE ASSESSMENT

Fairfield School
White Lee Road
Batley
WF17 8AS
UK

PREMISES PROFILE FOR FIRE

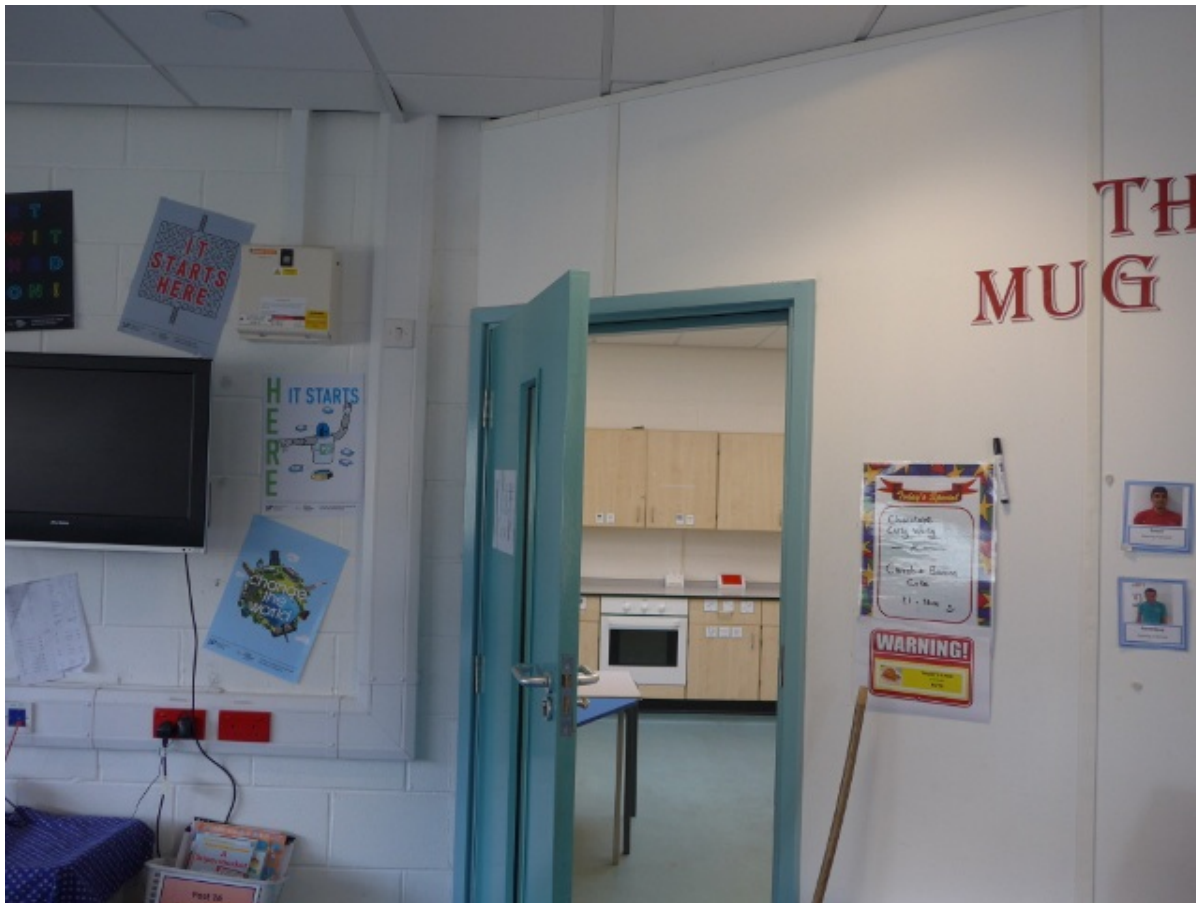
UID / REF: 1083038
 Building: Fairfield
 Floor: Ground Floor
 Room: Cooking Bay.
 Section: 4. DOORS AND PARTITIONS
 Sub Section: 1. Fire Resisting Doors
 Cause for Concern: Self-closing device(s) required.

- 6. Repair or replace the self closing device(s).

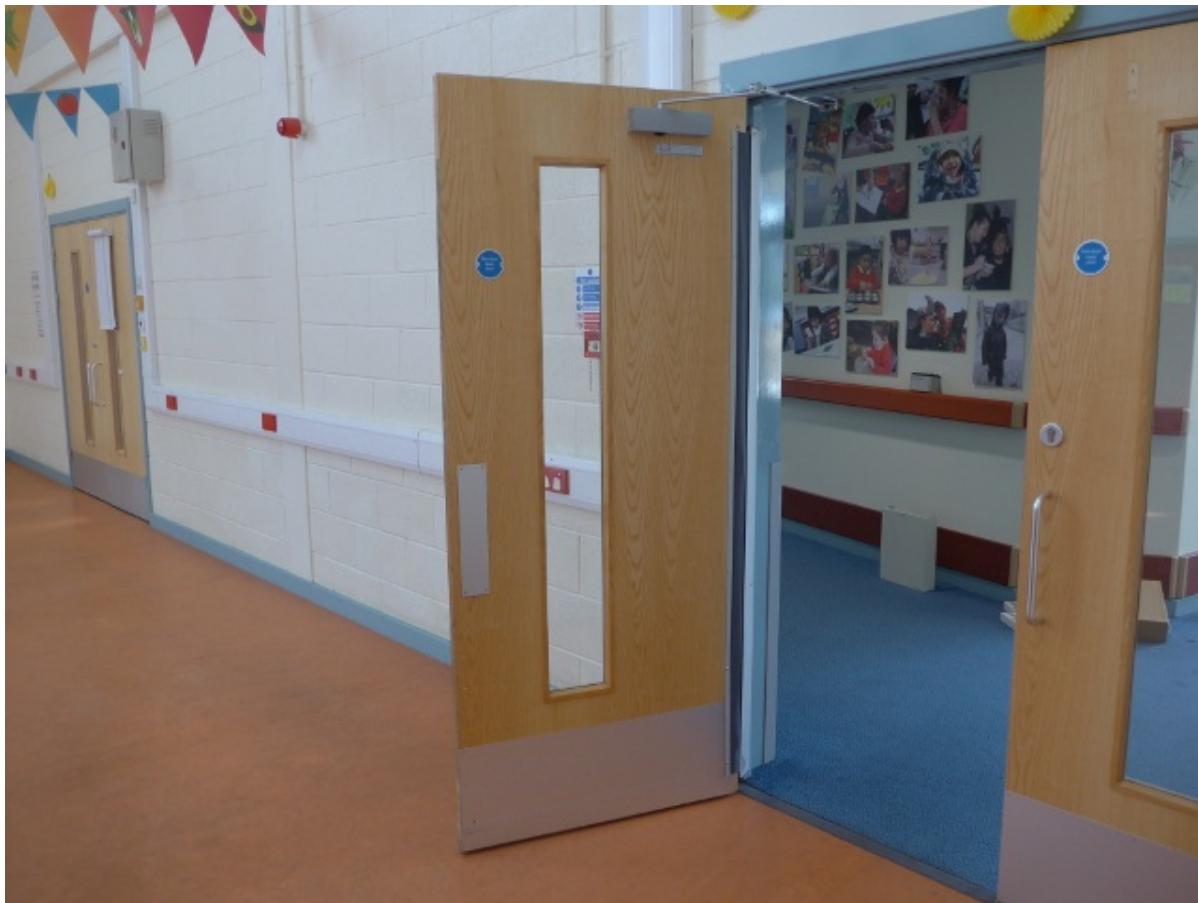
UID / REF: 1083041
Building: Fairfield
Floor: Ground Floor
Room: Dining.
Section: 4. DOORS AND PARTITIONS
Sub Section: 1. Fire Resisting Doors
Cause for Concern: Ineffective self closing devices.

- 6. Repair or replace the self closing device(s).

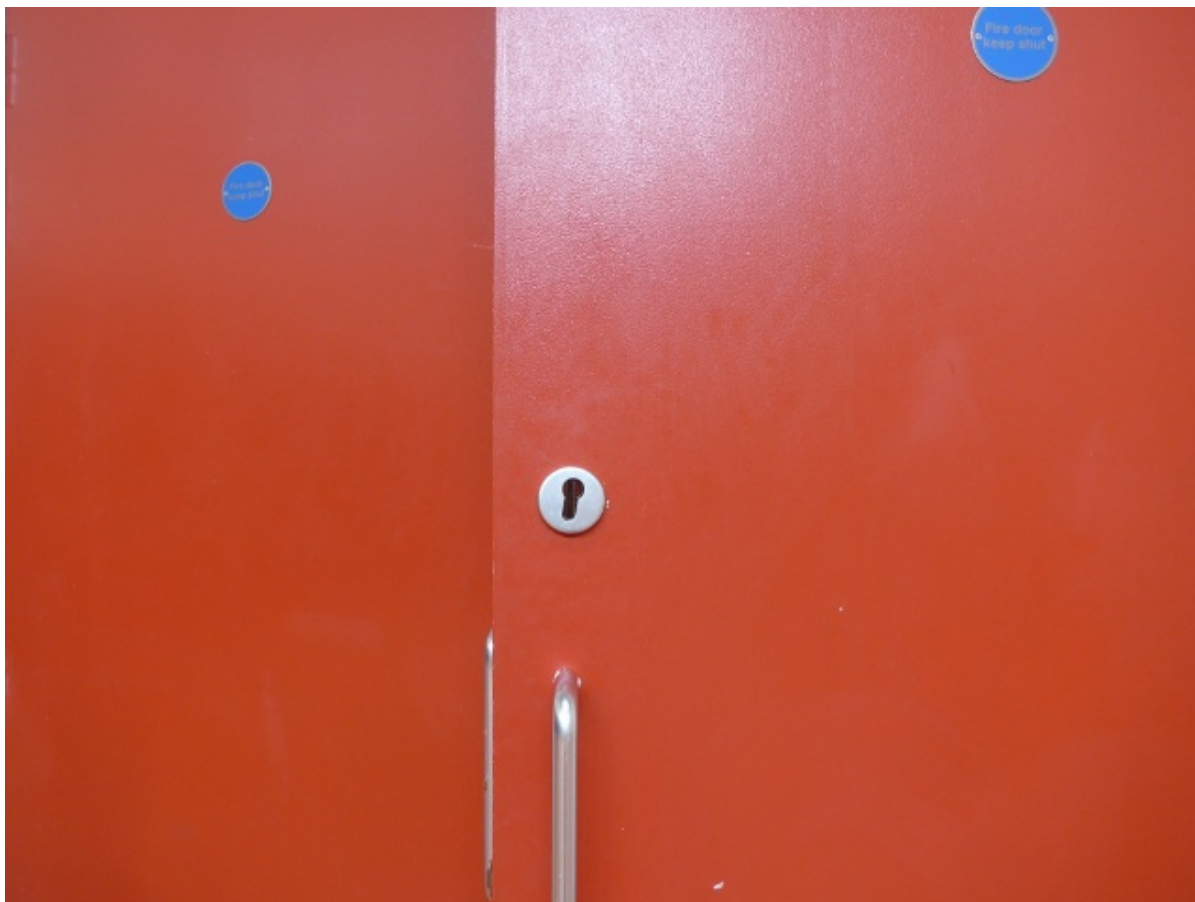
UID / REF: 1083046
Building: Fairfield
Floor: Ground Floor
Room: Hall/PE
Section: 4. DOORS AND PARTITIONS
Sub Section: 1. Fire Resisting Doors
Cause for Concern: (Other). Missing lock. The hole will affect the integrity of the fire door set.

To ensure the integrity of fire resisting doorsets:99. Replace lock or infill hole with fire resisting materials to the relevant standard. **Remedial Action Date: 90 Days**

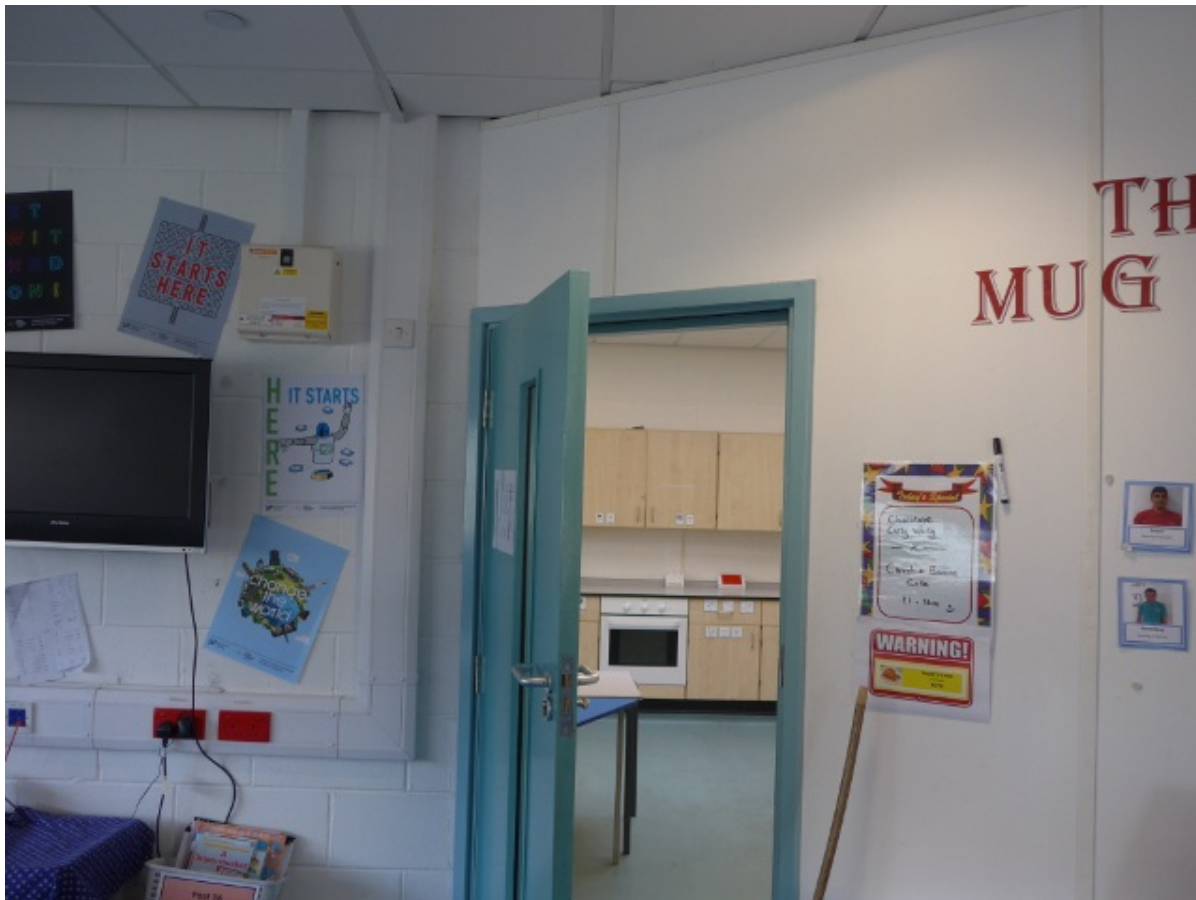
UID / REF: 1083039
Building: Fairfield
Floor: Ground Floor
Room: Cooking Bay.
Section: 5. SIGNS AND NOTICES
Sub Section: 1. Provision of Signs and Notices
Cause for Concern: Fire door(s) not provided with "Fire Door Keep Shut" sign.
